AIRCRAFT FIREFIGHTING AND RESCUE EXPERIENCES

The paper deals with the experiences gained from the firefighting and rescue operation executed on *Boeing 737-800* aircraft at the Belgrade Airport “Nikola Tesla”. It strives to describe the incident that occurred at the aircraft, as well as the executed rescue operation from the aircraft with 182 adults, 1 child and 6 crew members onboard. The paper further describes the reason for emergency landing and presents the applied firefighting and rescue tactics.

EMMERGENCY LANDING IN BELGRADE

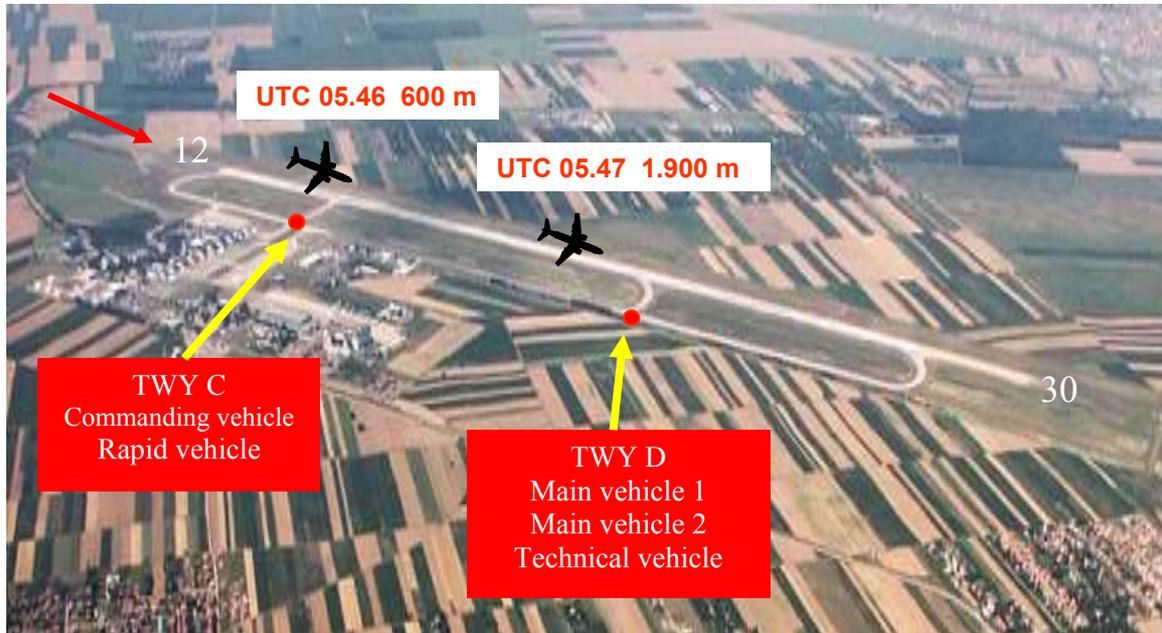
Slide 2: The position of the firefighting vehicles and the aircraft landing direction

Acting in accordance with the Plan for Emergency Situations at the Airport Belgrade, firefighting vehicles were deployed at the intersection points C and D of the taxiway and the runway, in such a manner that rapid vehicle “Panther” and the commanding vehicle took positions at the intersection point C, which is 600 meters away from the Threshold 12, while main vehicle 1, main vehicle 2 and technical vehicle took positions at the intersection point D, which is 2000 meters away from the Threshold 12.

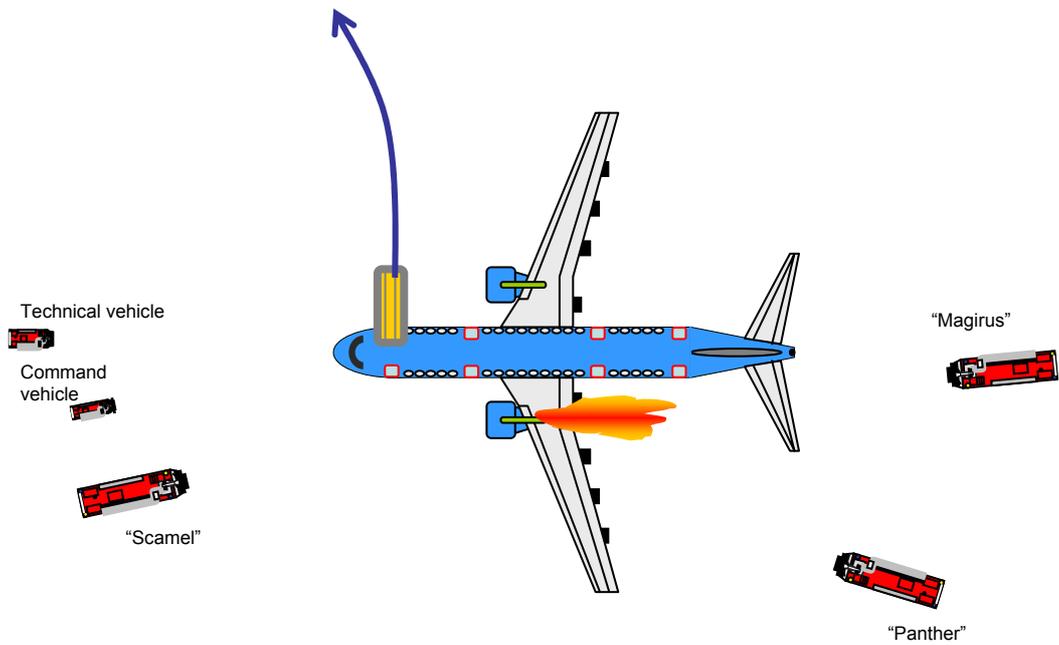
Slide 3: The position of firefighting vehicles just before the intervention

At the touch down point, the velocity of the aircraft was 250 km/h. The firefighting vehicles from the interception point D rushed after the aircraft that endeavored to stop as soon as possible by applying the brakes. As soon as the aircraft had stopped, the Main firefighting vehicles and the technical vehicle, positioned at the interception point D, started to move towards it. Main firefighting vehicle “Scamel” stopped at approximately 15 meters from the aircraft nose, while the other main vehicle stopped approximately 20 meters behind its tail. A few seconds after that, the rapid vehicle “Panther” reached the scene from the interception position C and took sideways position at approximately 20 meters from the aircraft tail. The commanding vehicle stopped in front of the nose, while the technical vehicle parked behind the commanding vehicle.

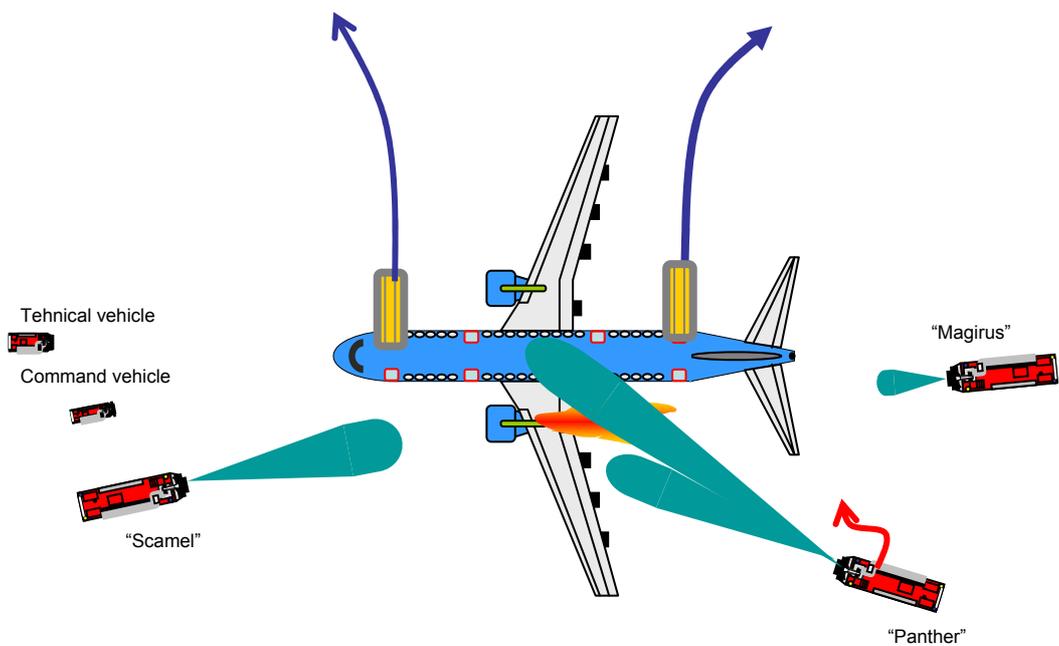
Slide 4: Engine firefighting

As soon as the aircraft had stopped, the cabin crew opened first the front door and then the back door on the right side of the aircraft, so the evacuation of the passengers by emergency evacuation slides commenced. The first spout of water was shot from the big water flinger of the "Panther" vehicle and directed towards the fuselage. The small water flinger operated into the center of the left engine which was on the fire, with the flame four meters long. All other firefighting vehicles shot the foam into center of the left engine. The fire on the engine was extinguished in 30 seconds, and evacuation of all passengers and crew members was completed in 40 seconds after the aircraft had stopped.

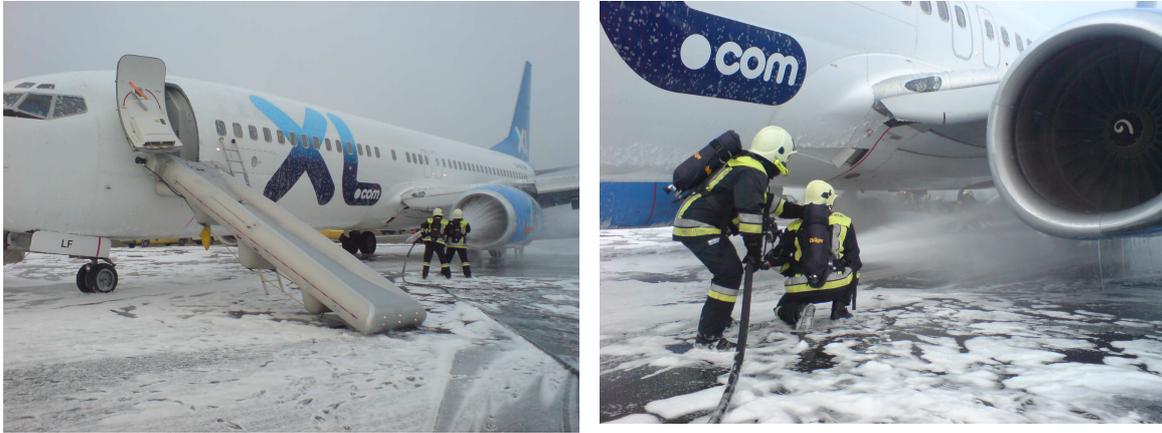
Slides 5 and 6: Cooling of the engine and the landing gear

Upon distinguishing the fire, the operation of cooling by reel hose commenced, first from the firefighting vehicles “Magirus” and “Scamel” and then from the firefighting vehicle “Panther”. Firstly, they cooled the left aircraft engine and then the landing gear that was overheated due to abrupt breaking of the aircraft.
